Lubrication moves up a gear

An unsuitable lubricant led to high gear temperatures and cement ingress in a US cement mill. The switch to a new lubricant led to a cleaner gear, reduced operating temperatures and fewer shutdowns. Three years later, the replacement lubricant continues to provide paybacks.

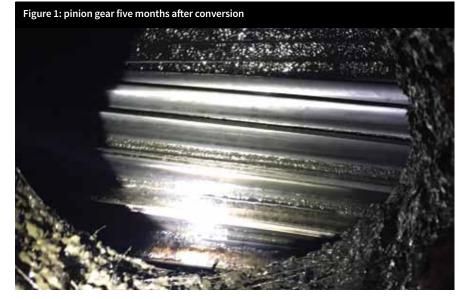
Despite the operating environment being the same as before, the maintenance team noticed a significant reduction in lubricant contamination with Pyroshield lubricating the gears (see Figure 1).

LE's Pyroshield product withstands high loads and runs at lower temperatures, preventing contaminants from sticking to the gear. It runs clean and does not require the gear to be over-treated with lubricant and too frequent spraying intervals. Moreover, as the product is 'self-cleaning', it does not require any supplemental cleaner to remove contamination.

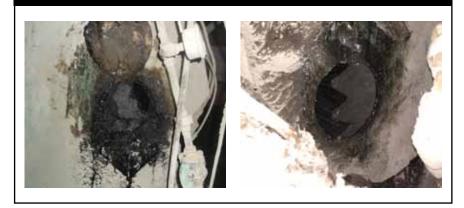
Figure 3: side door before (left) and following (right) conversion
