Customer Testimonial

Xclude® Breathers

Large PVC Manufacturing Plant in Central Georgia

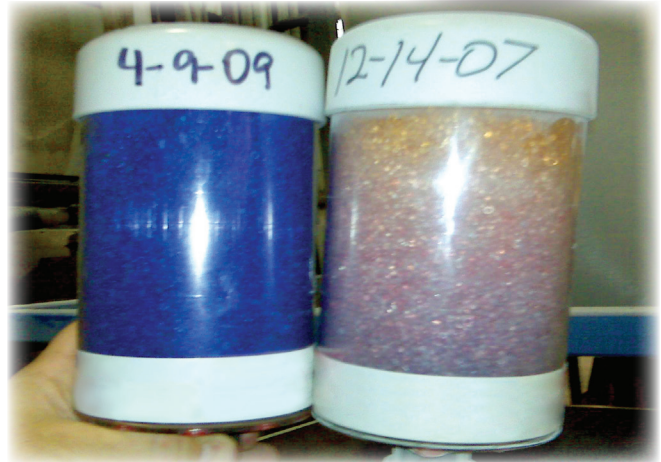
16 months of protection

the amount of ambient moisture in the environment in which they are operating. Look at the photos above, these breathers lasted 16 months and 15 months. Only four plugs were removed from the bottom of the breather.

One of the concerns was how long do the breathers last once they are installed on the gearboxes. Mark explained that when they are first installed, they last 1 to 3 months depending on the amount of water in the gearboxes or
