The Pursuit of
**Continuous
Improvement**
in Asset Management

New Reliability Maintenance Program

Delivered a **705% ROI**

by Clay Calk

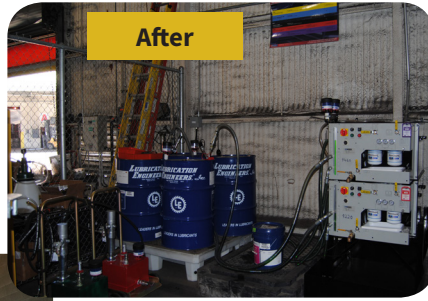
Figure 1: Reliability assessment

In 2012, Phase I began with the performance of a comprehensive reliability assessment and equipment and lubrication survey of all lubricated assets to understand the process, current lubricants and current practices in order to establish the program's baseline.

- Inspected and evaluated approximately 1,820 lubricated components.
- Discovered that:
 - Twelve percent of the application points were being lubricated with the wrong viscosity or wrong type of additive system per O&M specifications.
 - Consolidation opportunities existed to reduce lubricant products at Gallo by 31 percent.
 - Lubrication storage, handling and transfer facility required improvement per 5S initiatives.
 - Filtration, oil analysis monitoring and contamination control required attention.

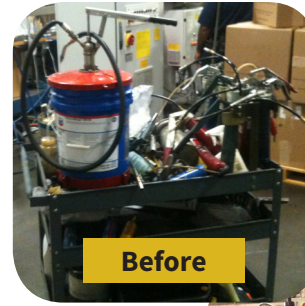
Figure 2: Before and after lubricant storage room

Phase II of the program transformation was to focus efforts on the lubrication storage and handling area to eliminate contamination where it originates (new lubricants). Furthermore, the existing lubricant storage and handling facility required improvement to Gallo's 5S initiatives, making this change a priority before moving the initiative downstream. The plan would include adding proper lubricant storage with three-way filtration and desiccant breathers, lubricant product identification and color-coding to mitigate cross contamination and lubricant misapplications on the plant floor. Organization and procedures for sustainability also would be part of the plan.

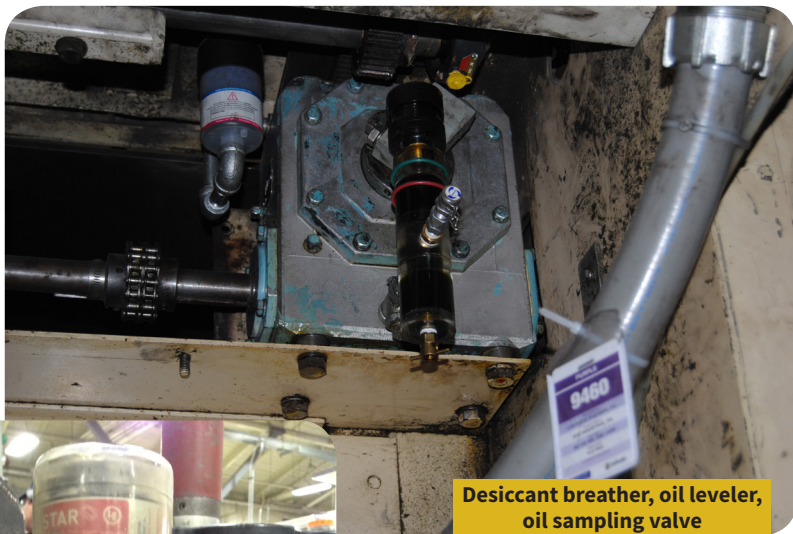
Desiccant breather, oil leveler, oil sampling valve

Figure 6 (a-c): Reliability hardware asset modification

First, moving from a time-based to a condition-based lubrication program, Gallo installed lubricant sampling valves in the primary sampling zone on all critical assets. This provided Gallo technicians the capability to pull accurate, representative lubricant samples on the fly while equipment was running to eliminate unnecessary downtime. Second, the program had to address the contamination control program for all critical equipment. This step was crucial in order to mitigate the most destructive particulates (e.g., dirt and water) that led to frequent oil changes and reduced asset lifecycle.

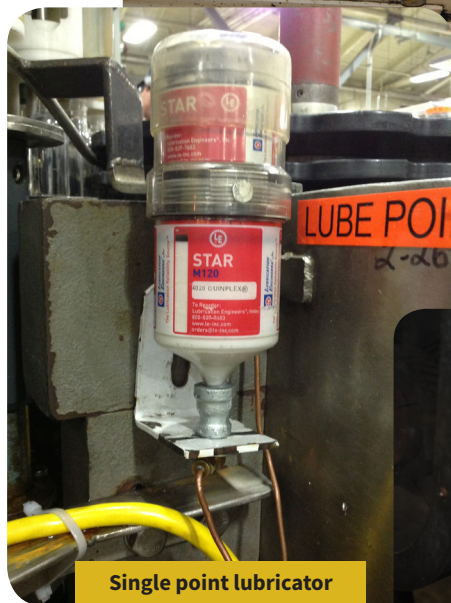
Single point lubricator

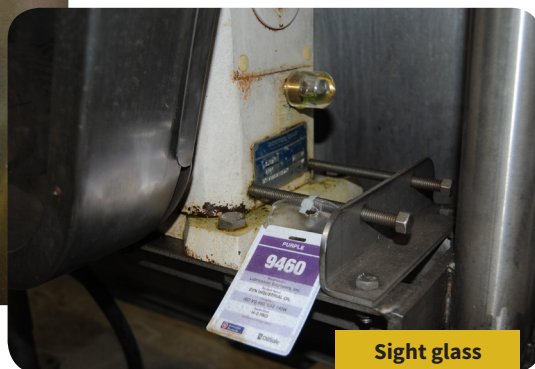
Sight glass

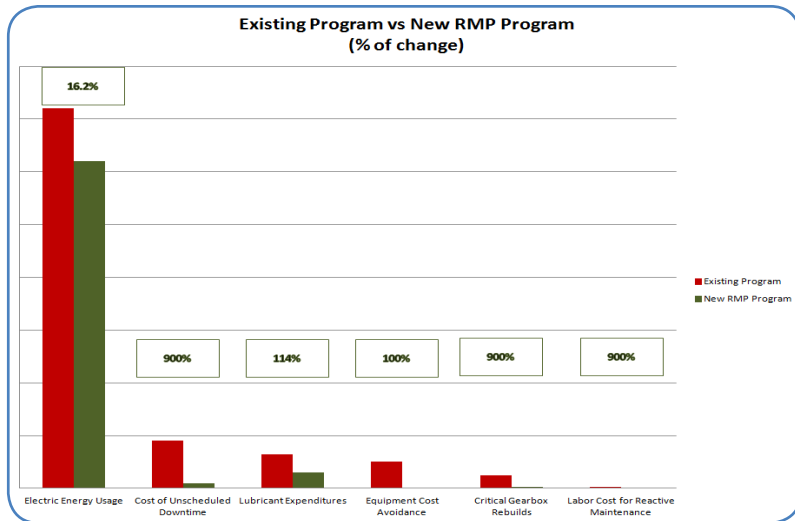
Figure 8: Program savings and variables measured

The data in Figure 8 demonstrates the existing program and associated costs for years 2011 and 2012 and compares this data to the new reliability maintenance program and associated costs for years 2013 and 2014. Overall plant equipment effectiveness improved by nine percent.

In performing the ROI calculations, the amount of financial gain achieved by Gallo was divided by its total program investment. The substantial and perpetual savings yielded a return on investment of 705%.
